Water Meadows, Woodstock

Water Safety Review

Version: Final
Date: 20/11/2023

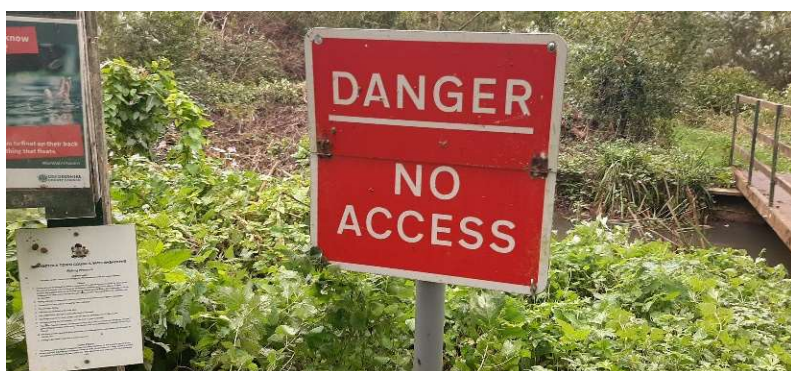
Example flood sign (flipped down for photo at time of visit)

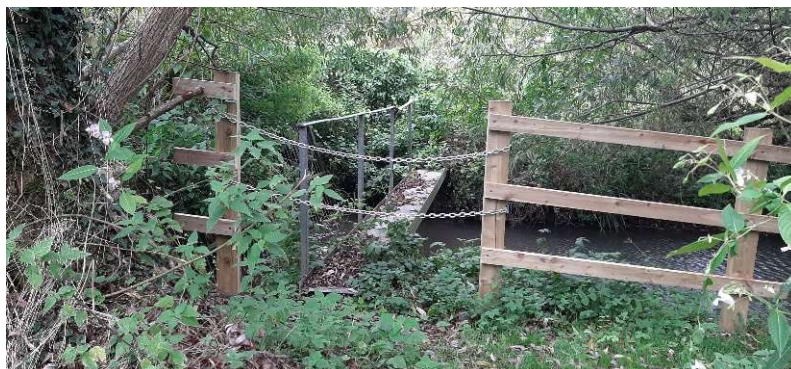
New fencing and chaining indicating restricted access to footbridge

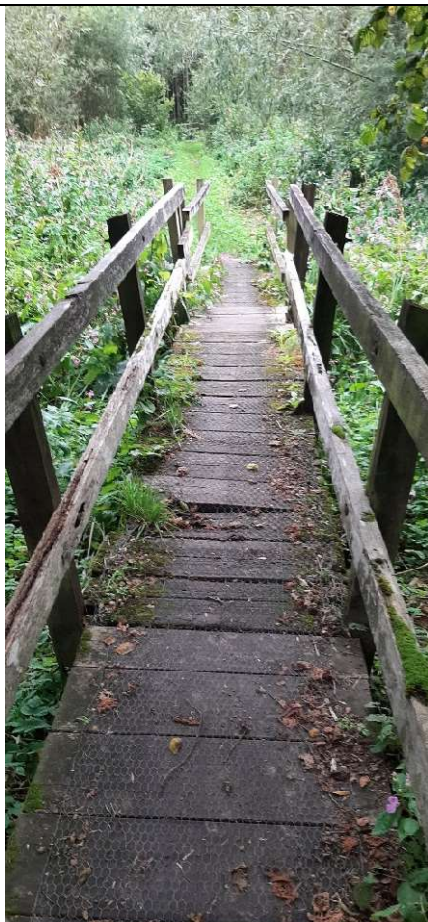
Footbridge – rotten boards (handrails and post, especially on LHS)

Footpaths are generally in a fair to reasonable condition. The footbridges and the wooden duckboards need attention and repair or removal.

No.	Recommendation	Priority	Action By	Completion Date	Signed
1.	Repair the boards on the footbridges.	High			
2.	Repair the handrails on the footbridges.	High			
3.	Remove or repair the wooden boardwalk areas on the pathways close to the channel.	Med			
4.	Ensure the risk assessment for the staff/ contractor clearance of materials from the weir grille includes the risk of a slip/ fall from the bridge.	Med			
5.	Refit the life ring near bridge 1 and clear the vegetation around the hook so that the life ring is visible and accessible.	Med			
6.	Monitor and record any movement/ vandalism of the life rings.	Low			
7.	Monitor any unauthorised fishing activities.	Low			
8.	Invite the local emergency services to visit the site to view the emergency access points on Brookside Court and Glyme Close.	Med			
9.	Continue to give water safety education to visiting school groups.	High

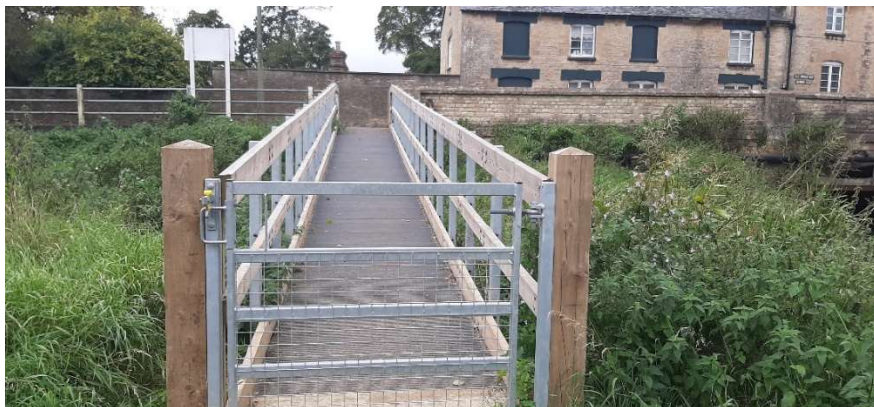
New access ramp

The new access footbridge is a good quality with handrails and a high friction surface.

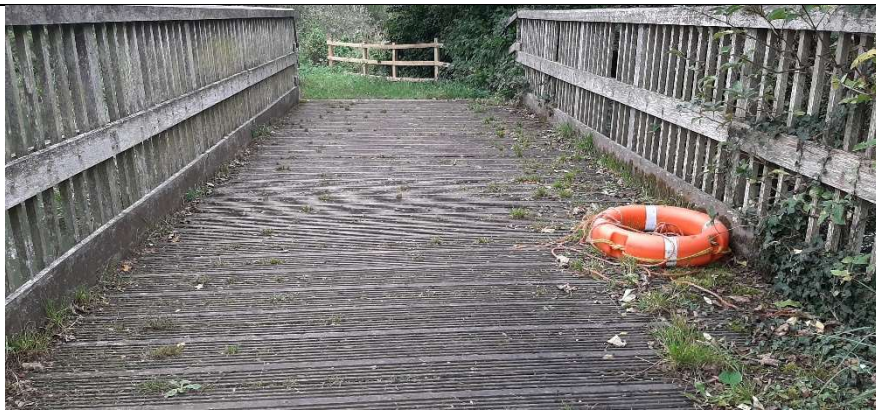
Bridge over weir with new post and rail fence in background and life ring with no housing etc.

Weir under bridge 1 has had the additional fencing fitted to restrict access to the fall. There was evidence of access to the pool area below the weir. The life ring has been moved from its intended position close to the bridge (photos available on request). The life ring was left on the floor.

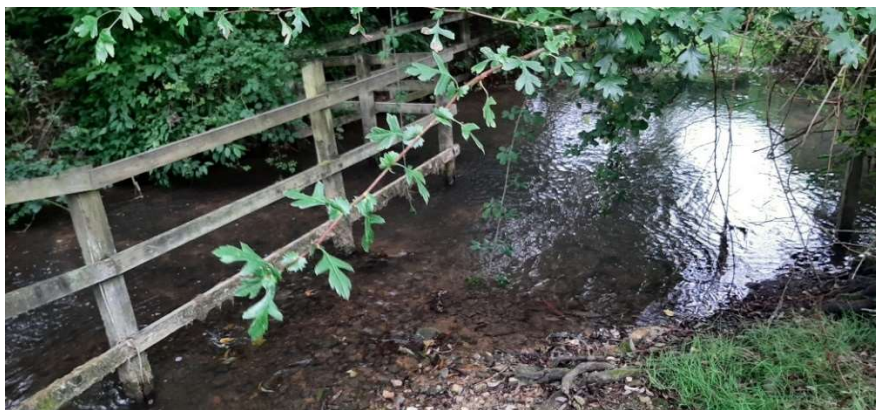
Access to the weir top is possible, but unattractive. A small pool has formed at the foot of the weir, but no unusual hazards were noted.

Small pool at foot of weir

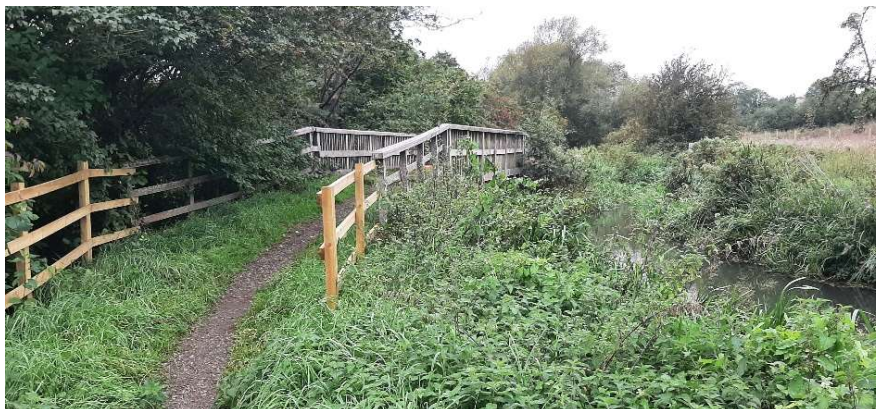
New fencing to bridge 1

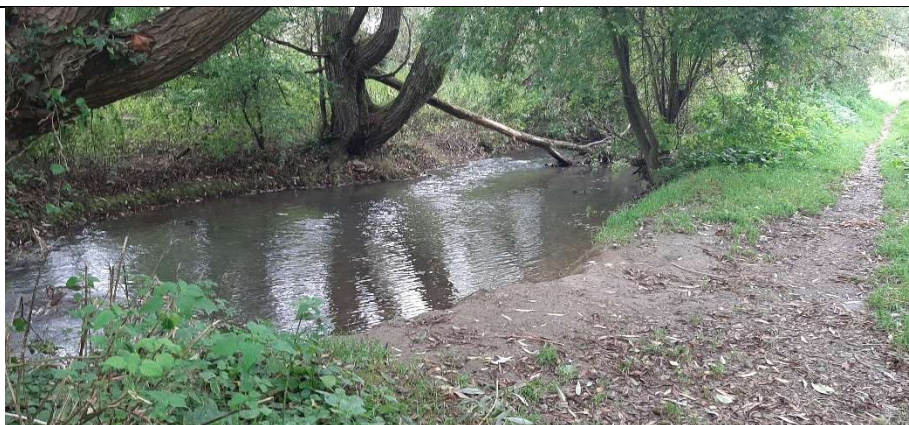
The River Glynne was a gentle, shallow stream at the time of the visit. The edges were identifiable and avoidable. The edges are mostly bagged or stone edges with a variable freeboard of approximately 400mm freeboard to the water. There is an area where access is easier. There are protruding angles and other similar items must be expected, these could, of course, cause a trip or a secondary injury, to anyone in or around the water.

Paddling/ animal access to Glynne. Metal angle is located in centre of bay.
